Westinghouse Astronuclear Laboratory

WANL-TNR-220

**NRX-A5 FINAL REPORT**

NRX-A5 Test Assembly Mated to Test Cell "A"

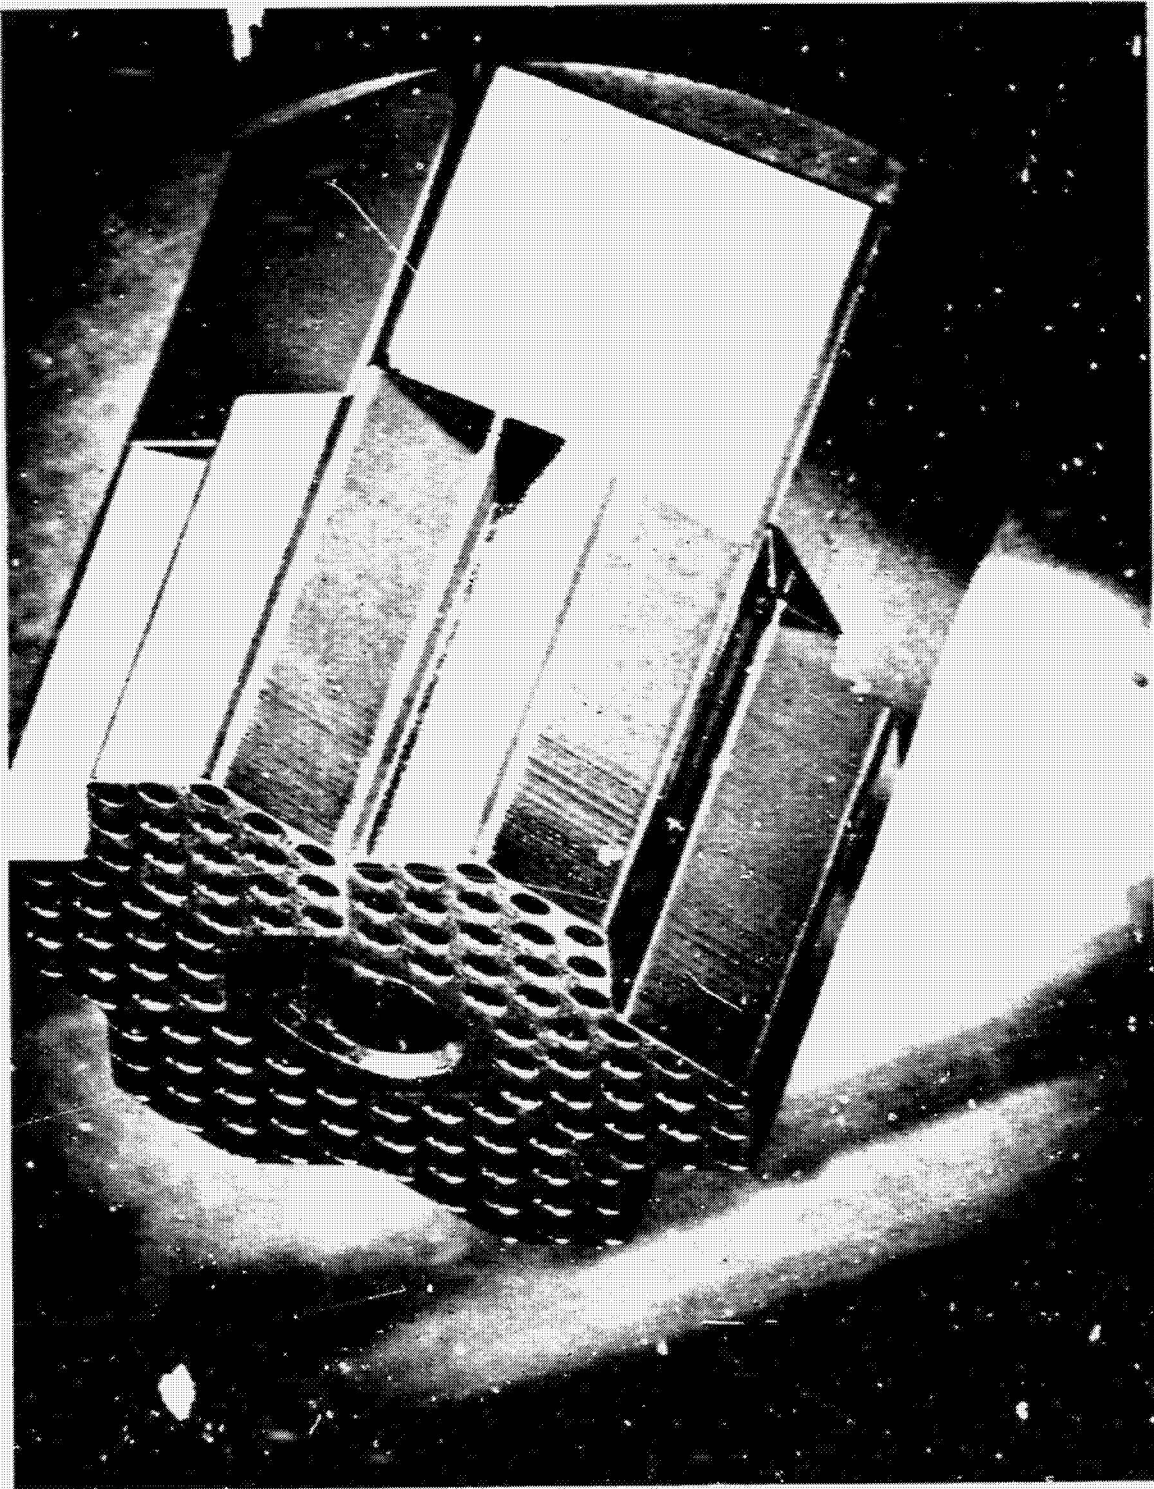
Figure 23. Regular Support Block

The condition of the NRX-A5 regular support blocks (those having six symmetrical lobes) was generally better than that of the NRX-EST blocks, with only minor corrosion,

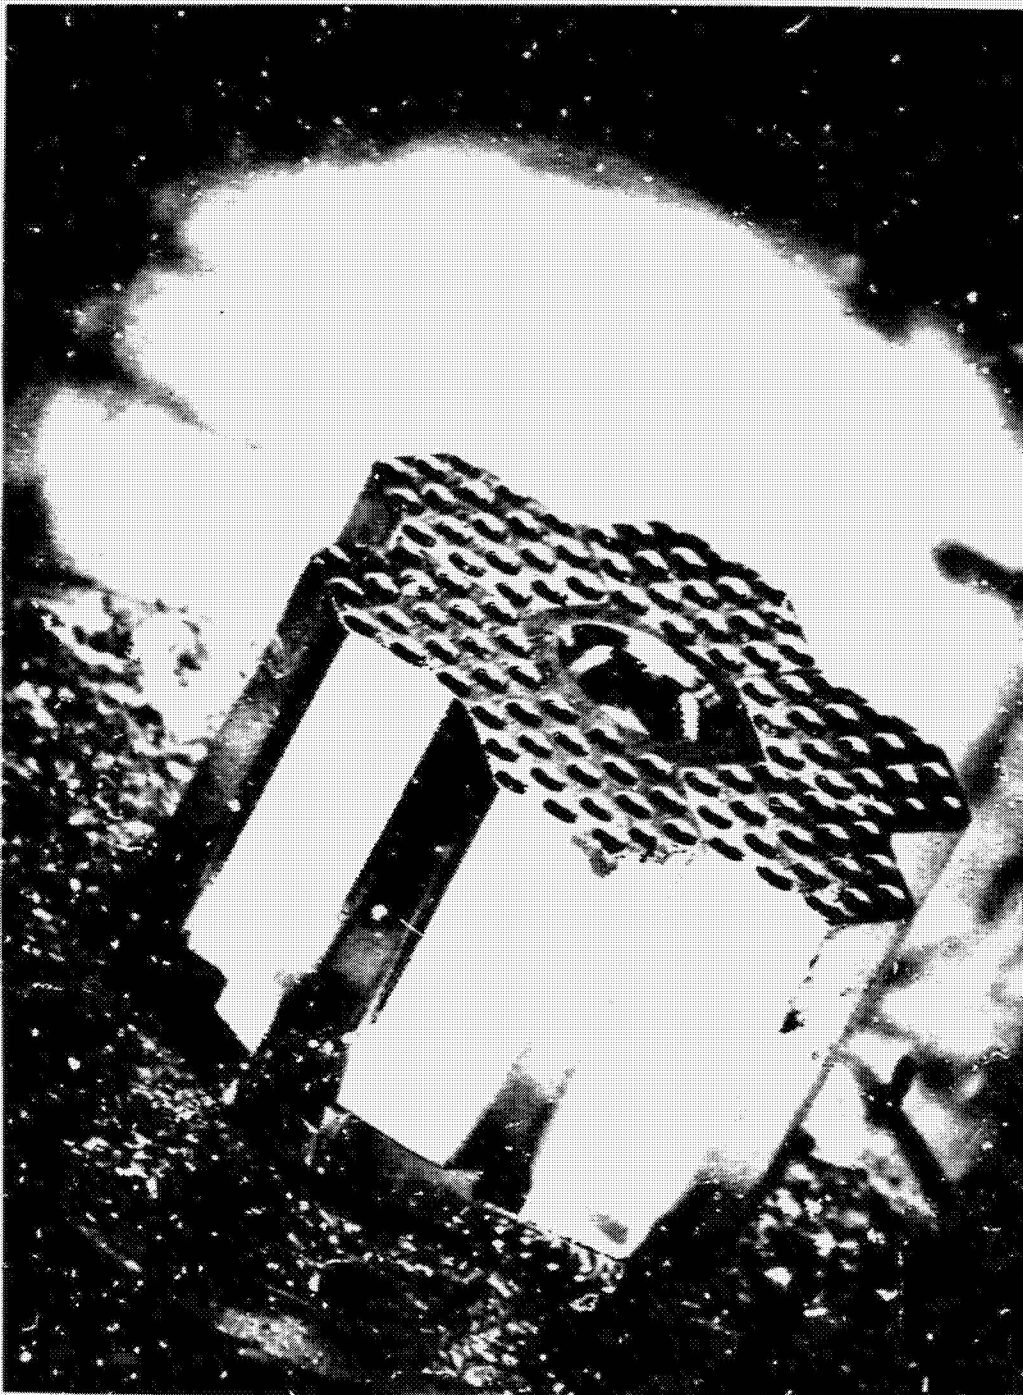
Figure 24. Skirtless Support Block

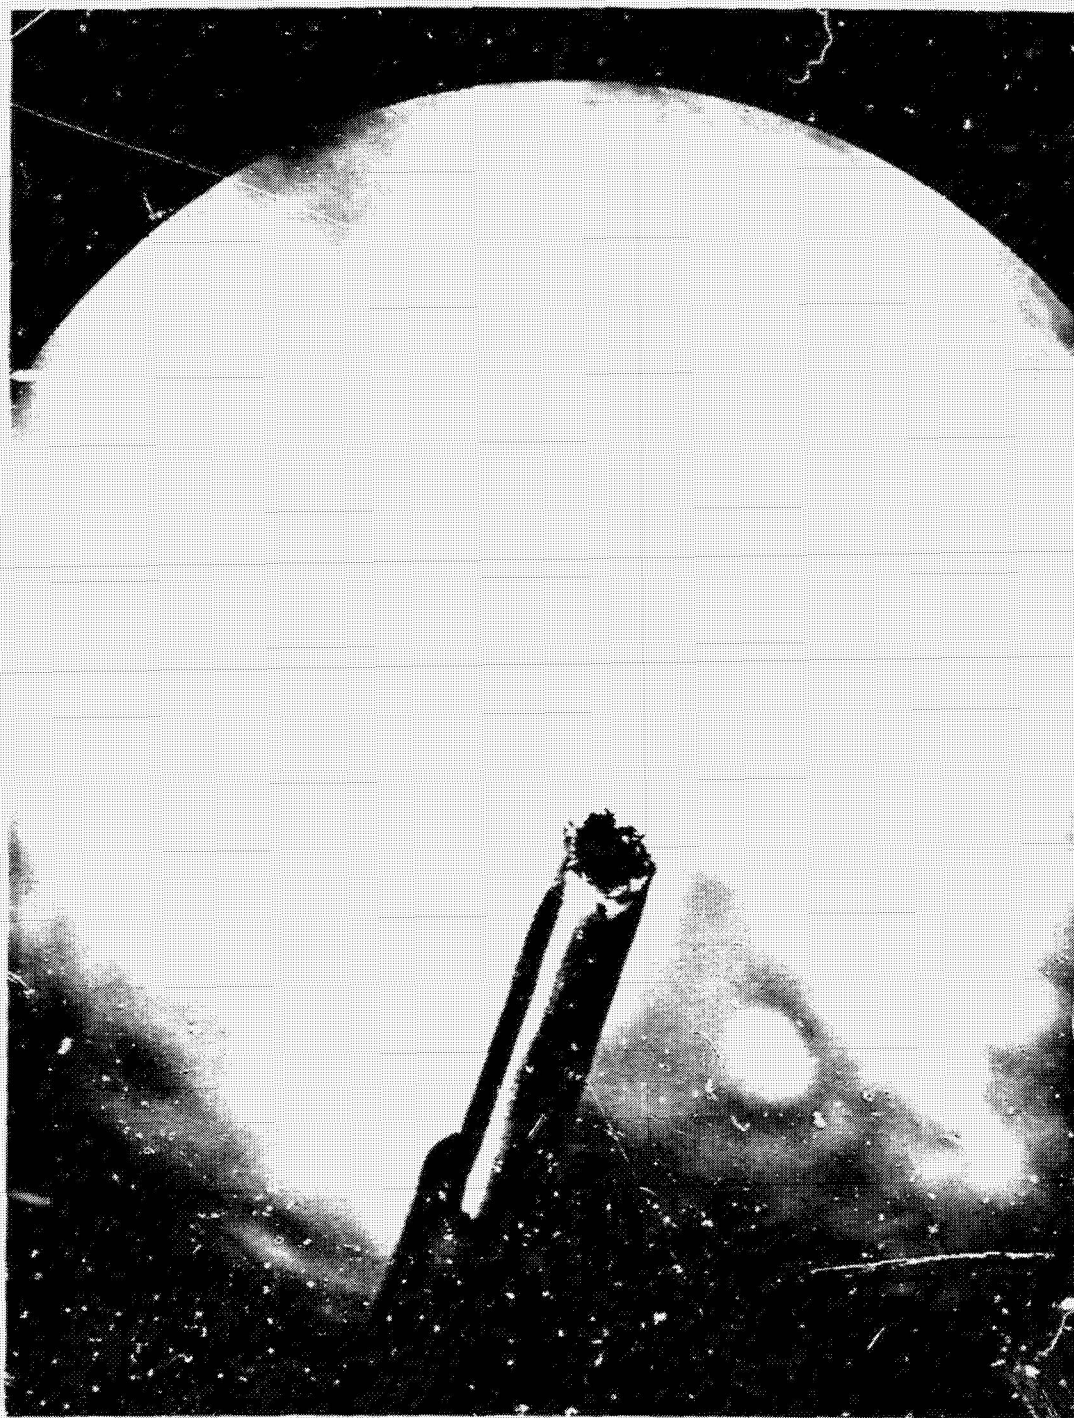
Figure 25. Severed Liner Tube, SF5 Cluster, Station 42

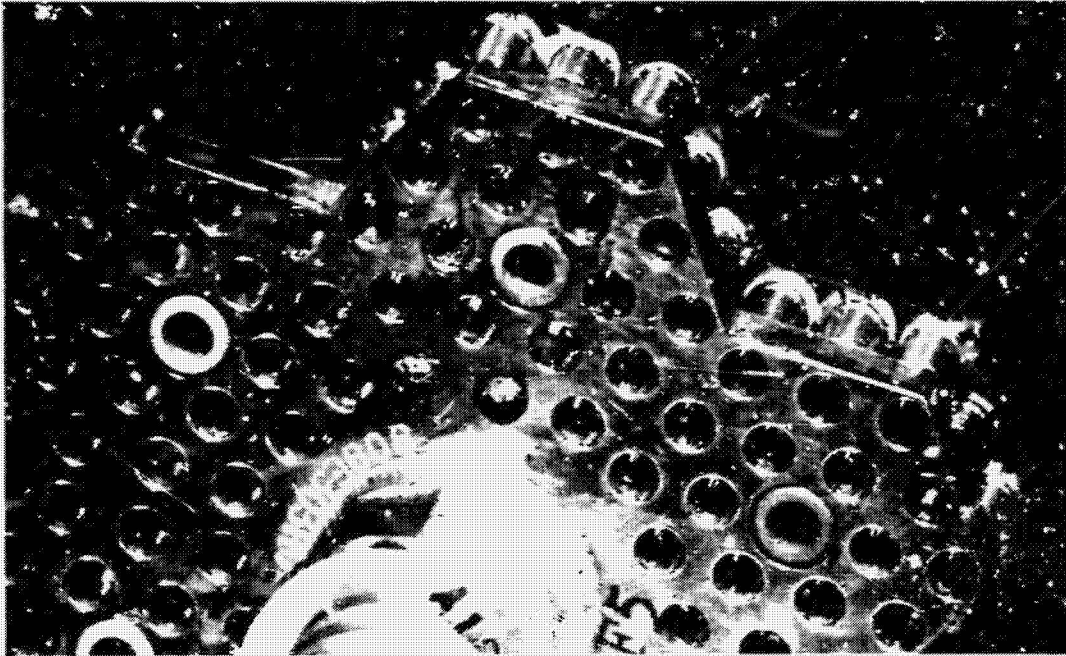
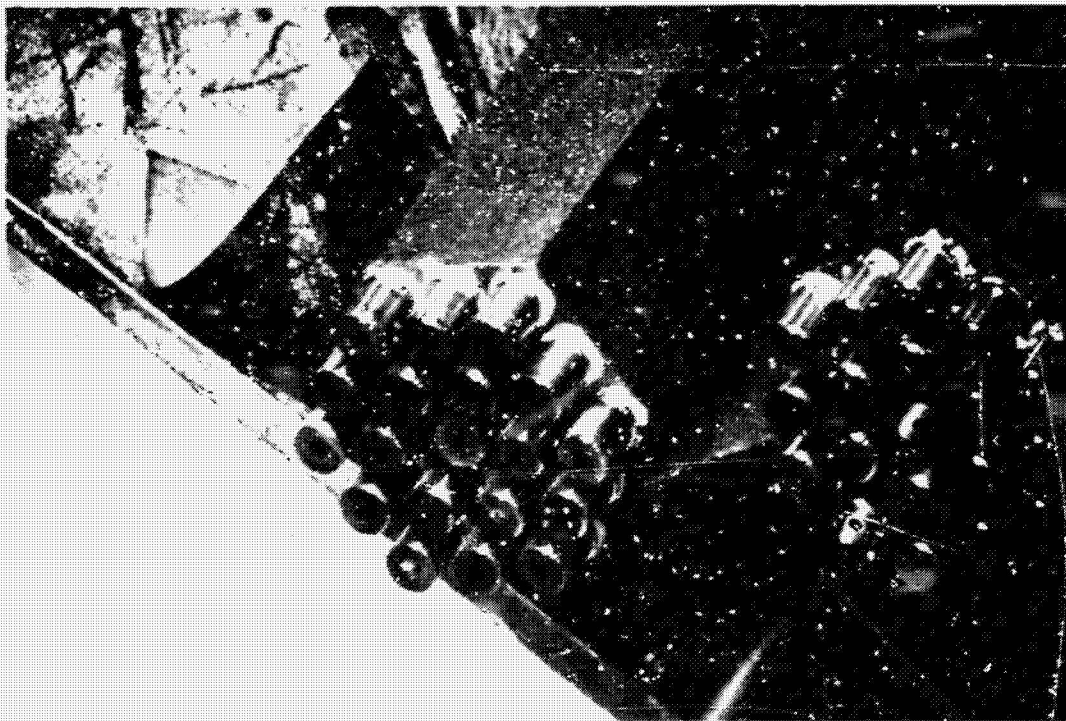
Figure 26. Blocked Orifices, 5F5 Cluster Plate and 5F5C Fuel Element

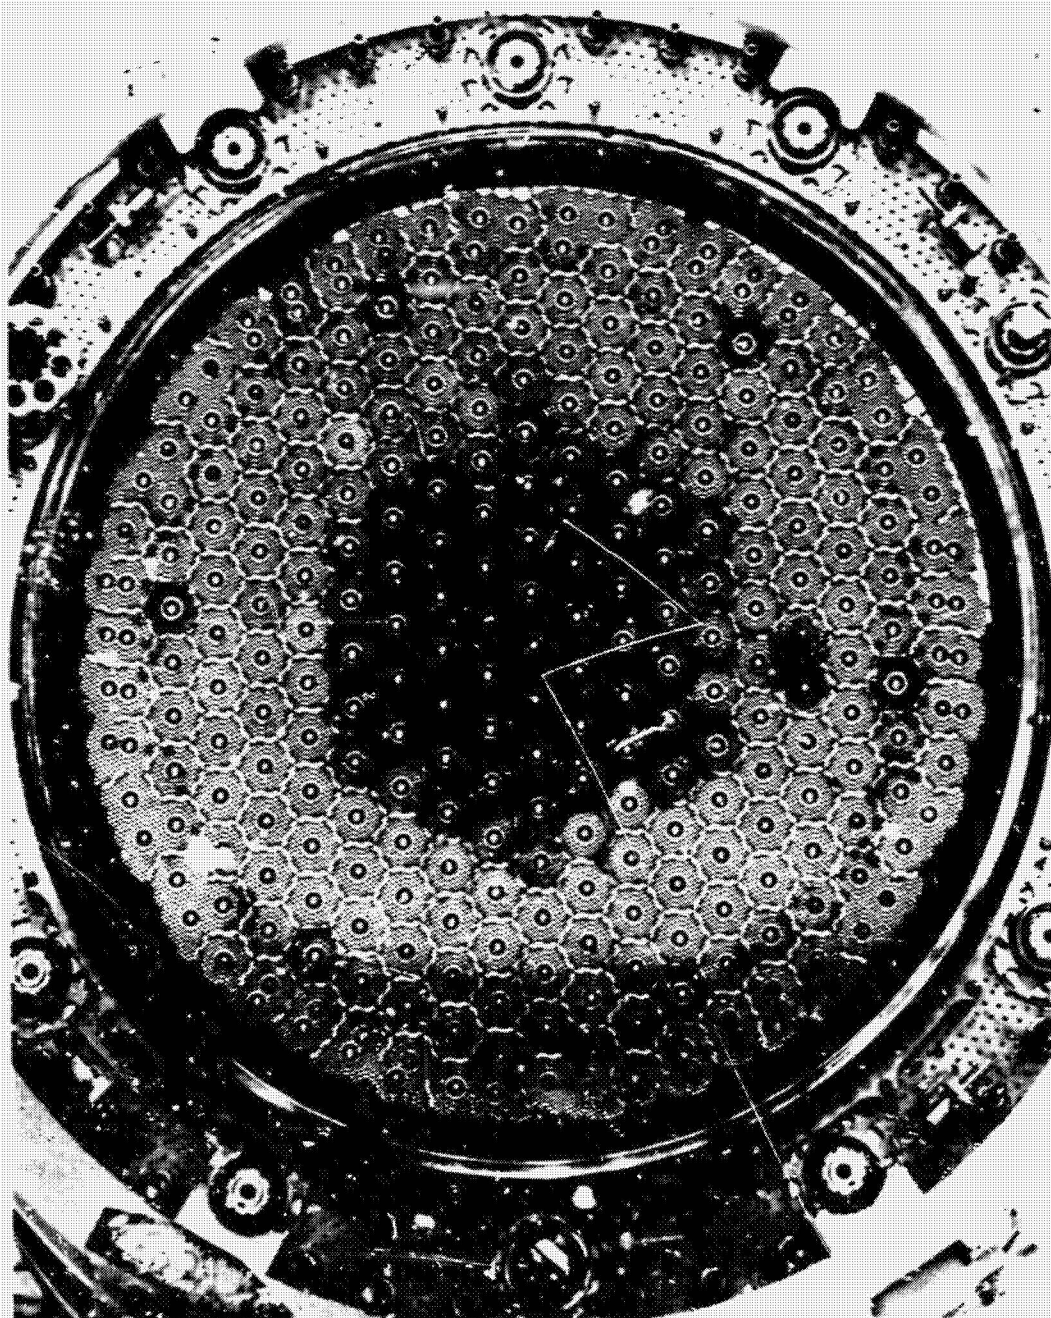
Figure 27. NRX-A5 Core Exit, Showing Sooting Patterns

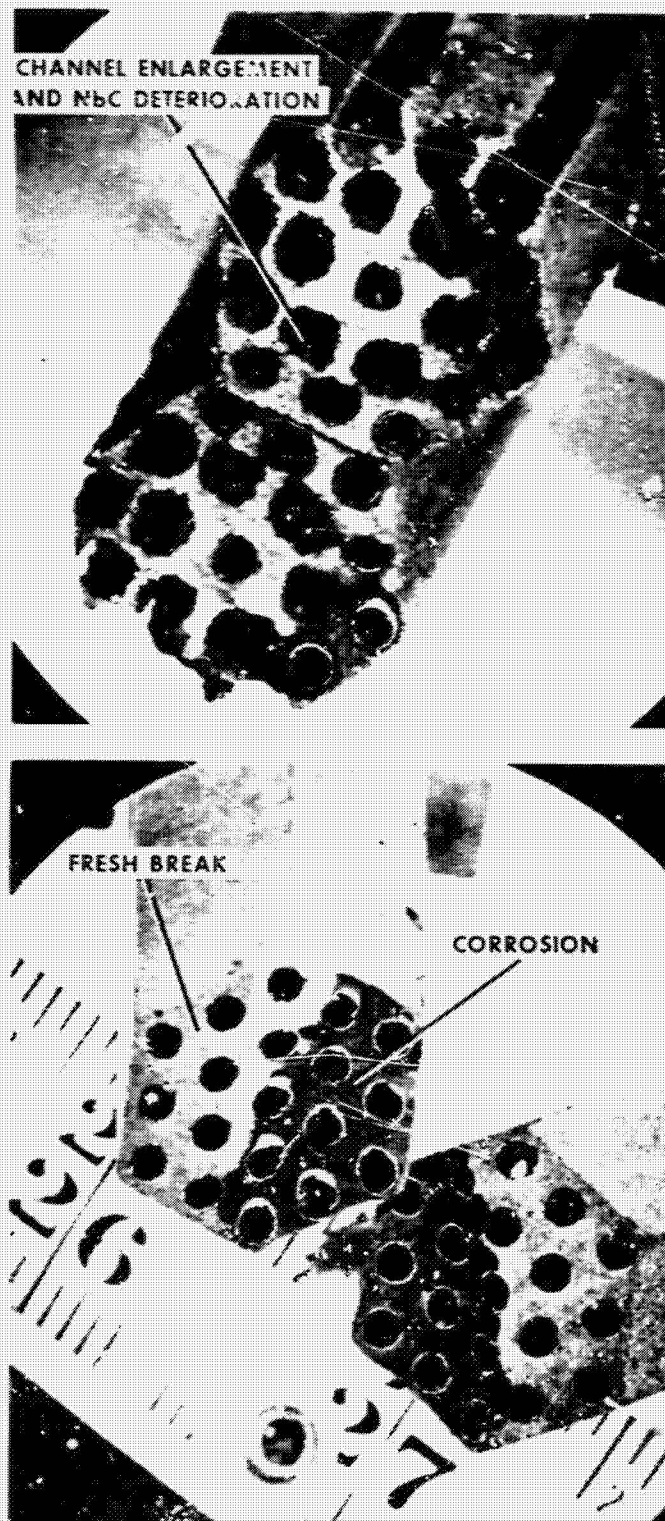
Figure 28. Fuel Element Breaks

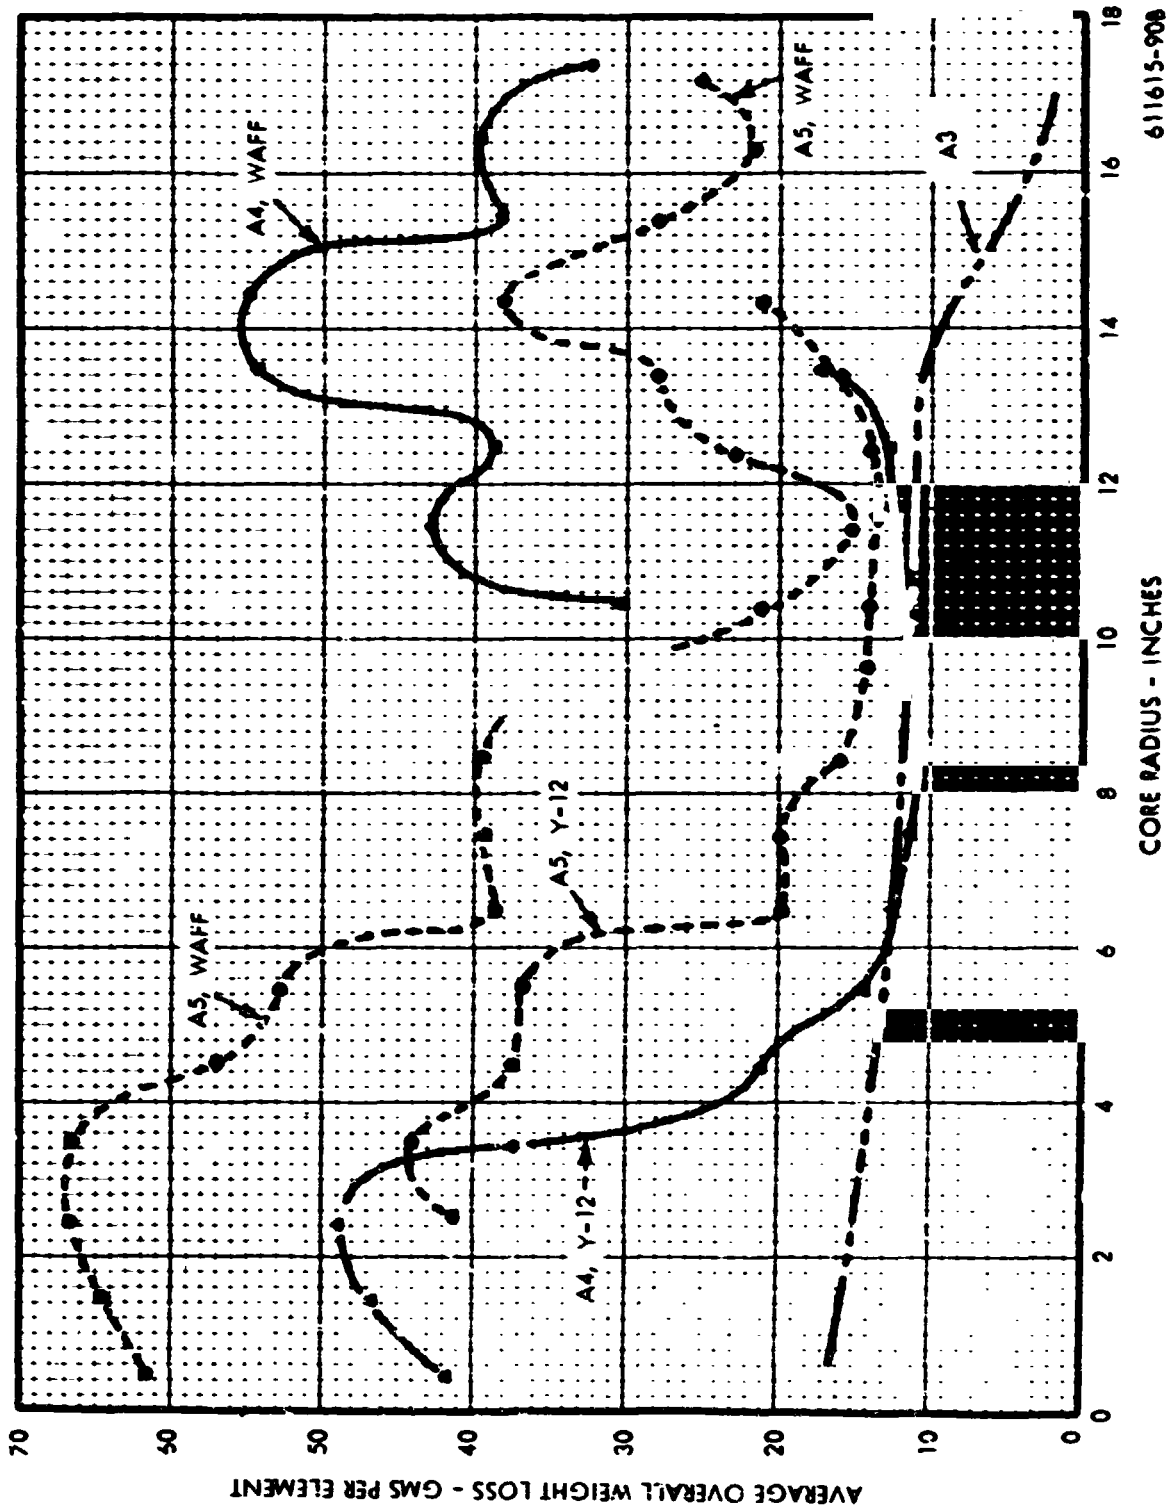
Figure 29. Fuel Element Weight Loss Versus Core Radius

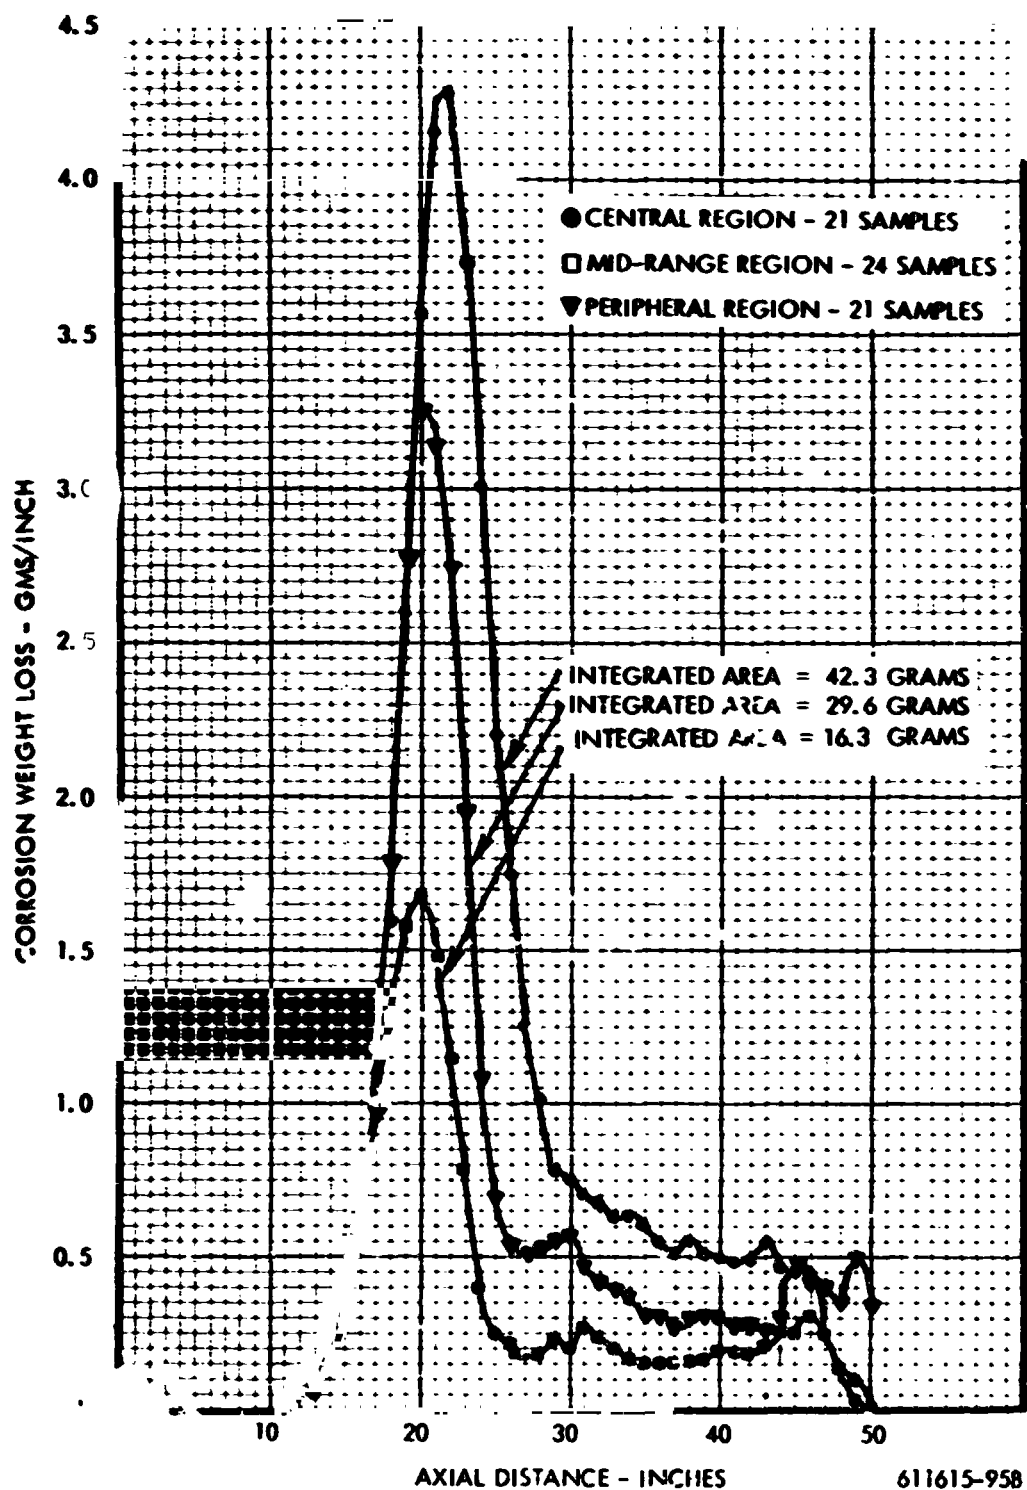
Figure 30. NRX-A5 Incremental Weight Loss

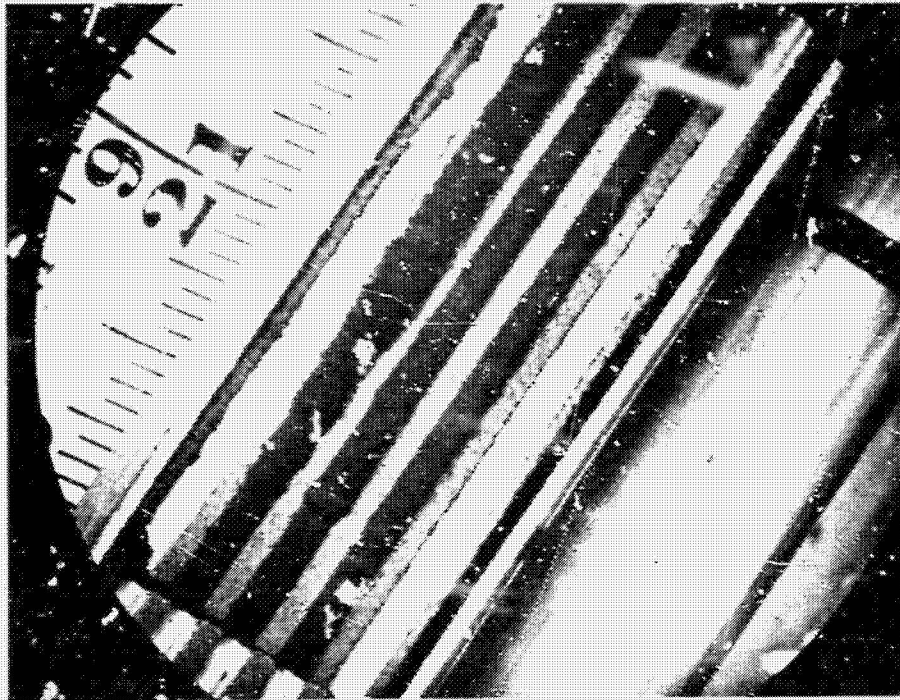
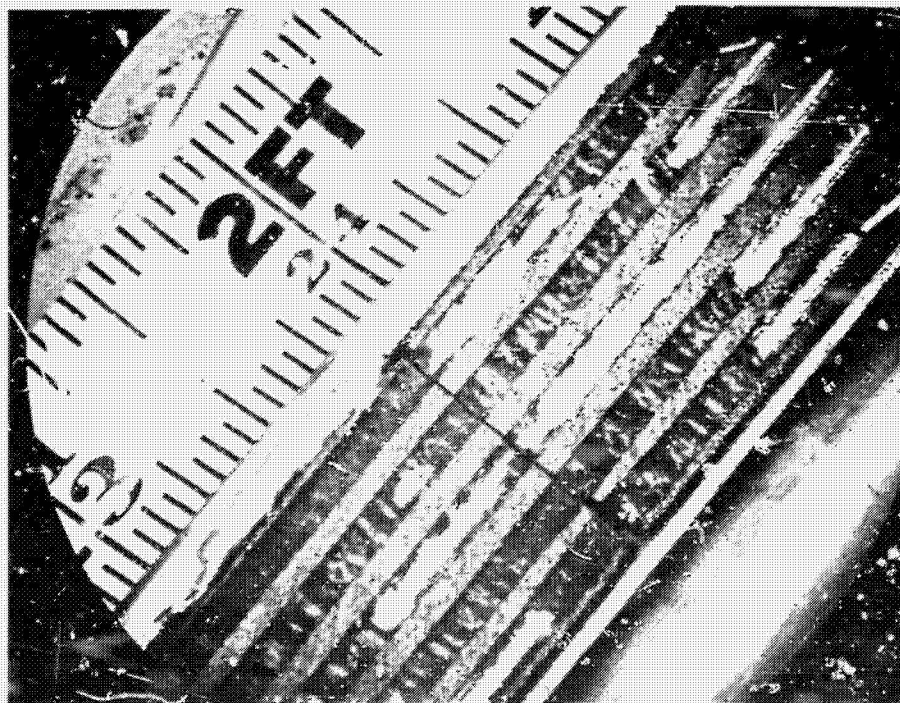
Figure 32. Comparison of Axially Sectioned Adjacent Elements

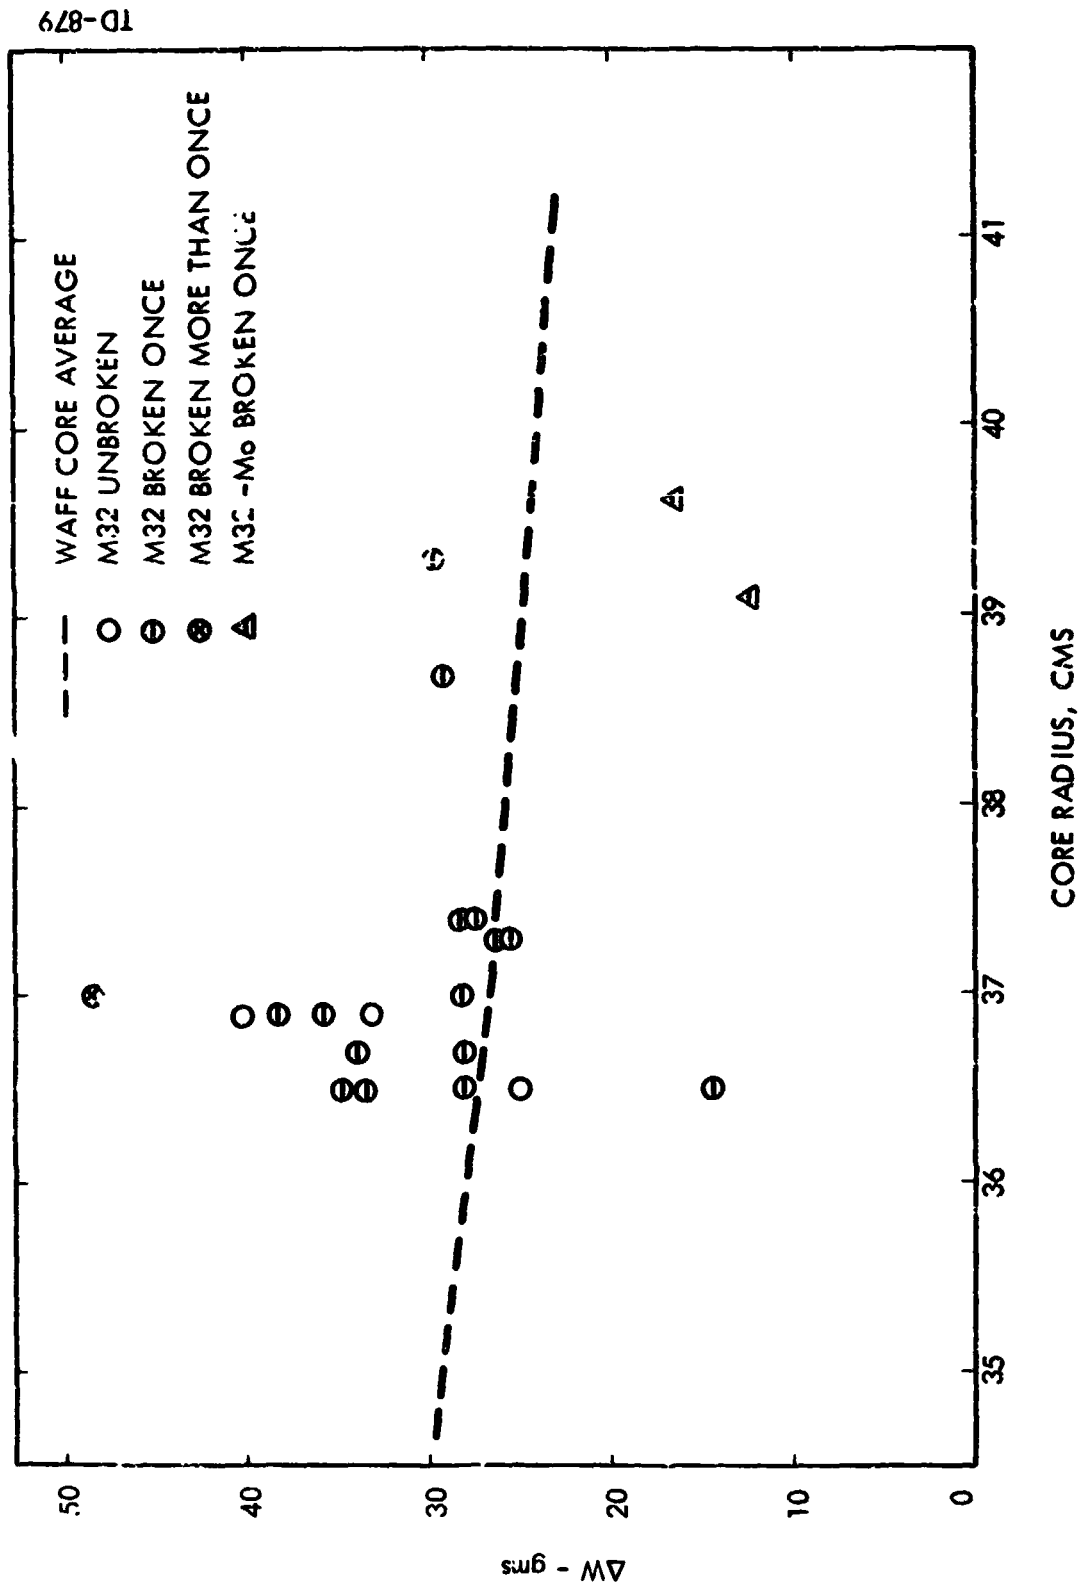
Figure 33. NRX-A5, ΔW "Versus Radius For Batch M-32
